On-site replacement of OLTC, drying of winding insulation, induced voltage test with PD measurement of 250 MVA, 400/110 kV, 40 year old transformer

M. SZROT, J. PŁOWUCHA, R. KUBICKI, R. MALEWSKI*
Energio- Complex Malewski Electric
Poland

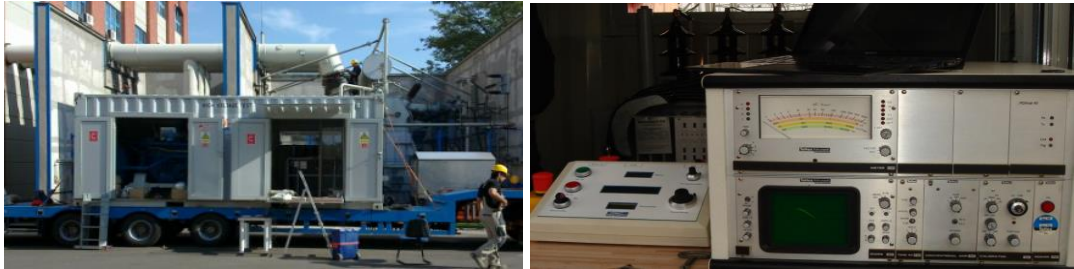
Fig.1. Mobile motor-generator set on a trailer and Partial Discharge level measured by Tettex 9120.

To assess insulation condition the induced-voltage test was performed using a diesel-engine and three-phase 300 kVA generator with frequency regulation. This mobile motor-generator set was rented from Hungarian enterprise that has operated this equipment. The generator output-voltage excited the transformer tertiary-winding through a step-up transformer [13]. At 60 Hz the test voltage attained 110% of the rated 31,5 kV of the tertiary and 400 kV of the primary winding. Measuring equipment of this mobile unit included 9-channel 12 bit analogue-to-digital (A/D) converter with measuring channels to record the supplied voltage and current, as well as 6-channel PD measuring system type MPD 600 with PARD algorithm to locate PD source inside the transformer [14]. Besides, an acoustic PD localisation system type PDL 650 and Tettex 9124 conventional PD meter were included.

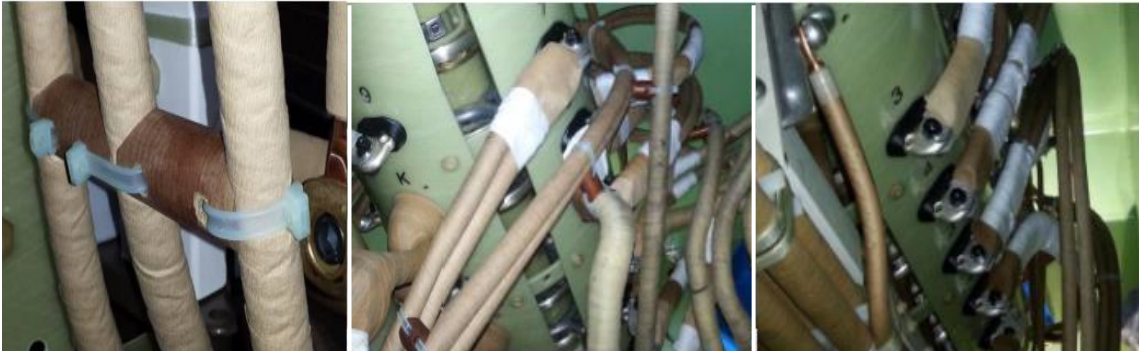
Fig. 2 Leads connecting OLTC selector to the tap-winding. Joints between original lead and its extension were clamped and insulated with wrapped tape, inside the tank. Spacers ensured the distance between the leads calculated according to their respective voltage-difference.

No welding, soldering or filing is allowed inside the tank, and the lead connections were made by pressing joints of 2x240 mm² Multiflex copper-conductor with a special tool. Insulating spacers made of phenolic-paper and epoxy reinforced glass-fibres were installed between the OLTC leads to keep their distance calculated for the respective tap-selector voltage, and to ensure required dielectric strength. Although tedious and skill demanding work has taken time, but the strict working procedures were enforced and controlled. At this stage one can say that "Devil is in the Details" has not lost its novelty.

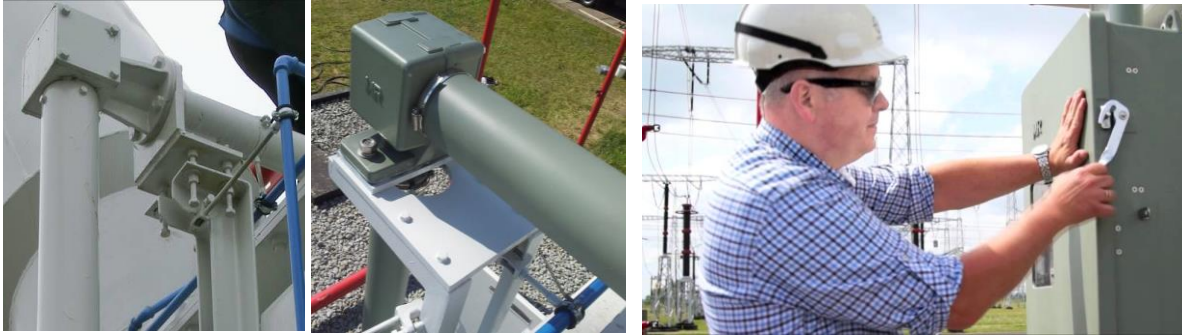
Fig. 4. Original and replaced angle-transmission of OLTC drive. The new OLTC drive.

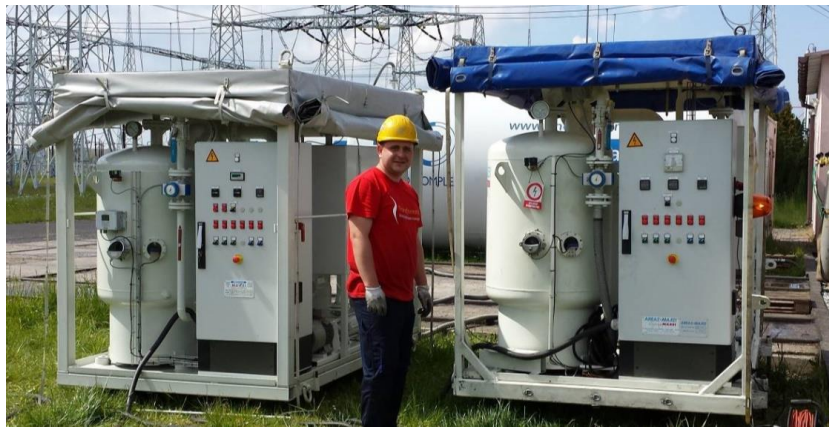
Fig. 5. MAS-600 oil processing system warming up oil that circulated through the transformer.

Once the new OLTC connections were checked the transformer insulation was subjected to the heating and vacuum drying, since the new lead insulation was not oil impregnated and despite all precaution the winding insulation-surface may have absorbed some atmospheric moisture. Two series connected oil-processing systems MAS 600 with total heating power of 200 kW were employed to warm-up the oil by 65°C and to circulate the hot oil through the transformer then through the filter and degassing chamber.

The two oil processing system allowed for two-stage warming the transformer active part as well as oil de-gassing and drying.

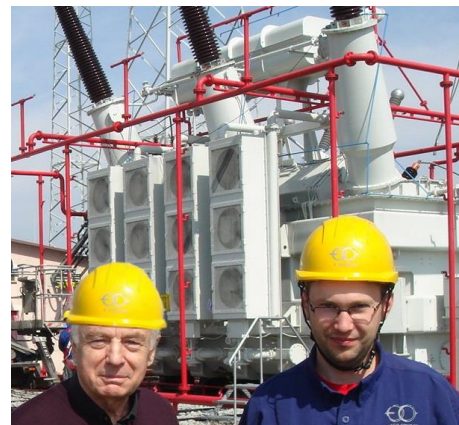
Fig.7. 250 MVA 400 kV transformer after the acceptance tests.

As no problems have been reported the transformer was brought back to regular service, and performs satisfactorily till now, according to the owner.
